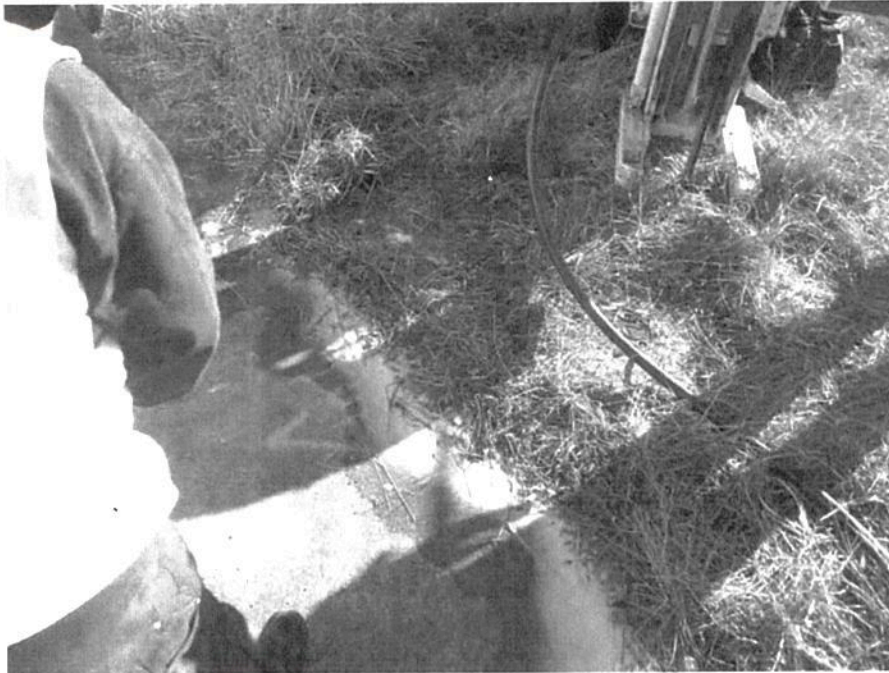
**PHOTO 21:**

Same. Daylighting  
between grassy area  
and concrete pad.

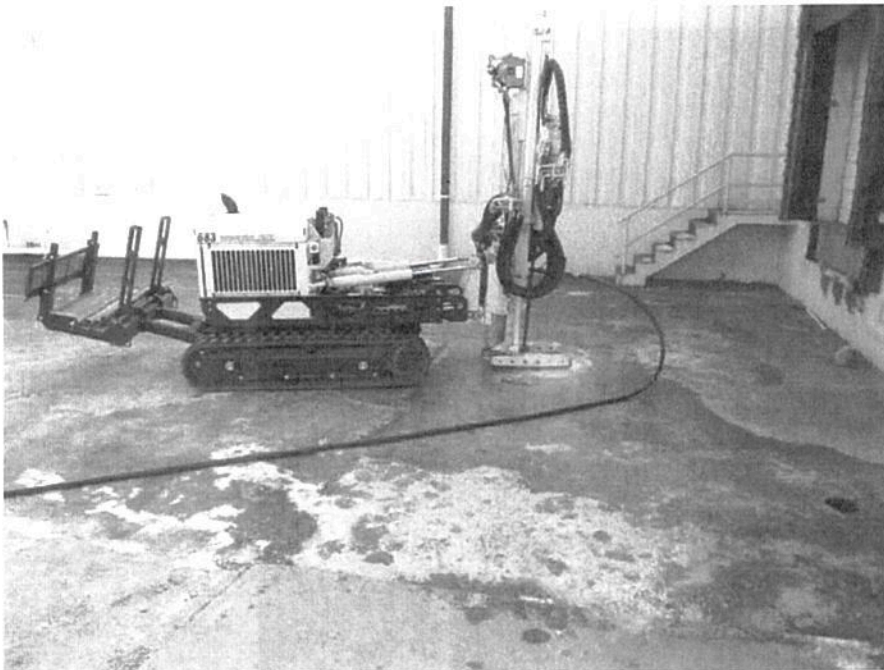
**PHOTO 22:**

3DMe injection near  
MW-5 and MW-5M.

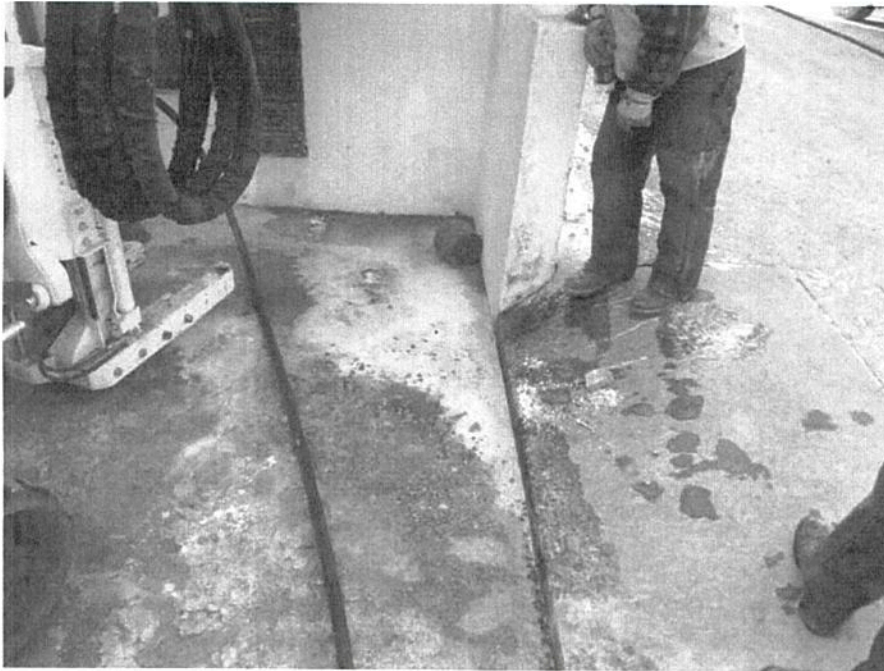
**PHOTO 23:**

Same. Daylighting  
seen between concrete  
ramp and loading dock.

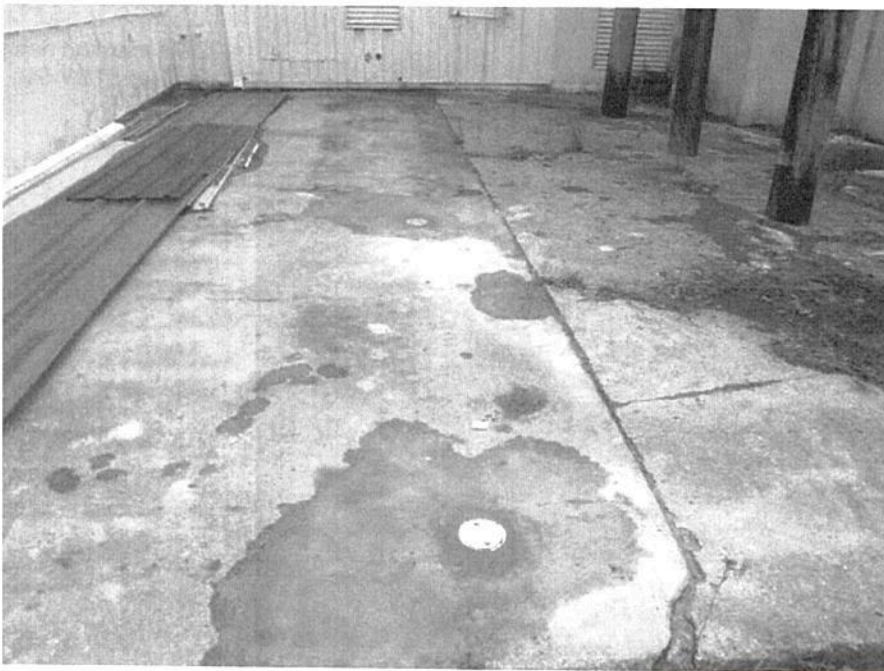
**PHOTO 24:**

Newly installed  
permanent injection  
points F35P and F36P  
near west gate.

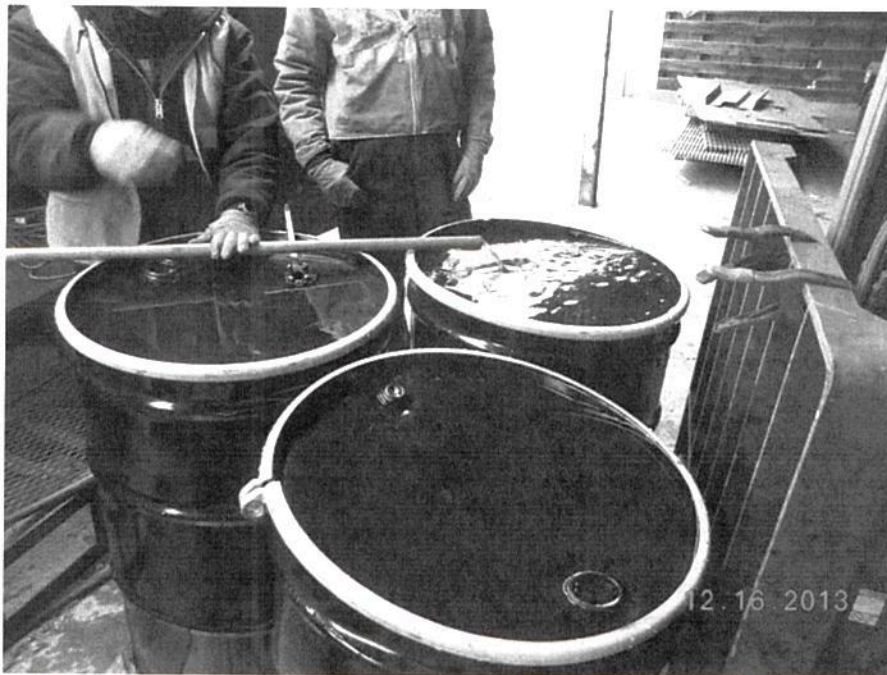
**PHOTO 25:**

AST representatives  
hydrating BOS 100  
drums to displace  
nitrogen and never  
contact with air.

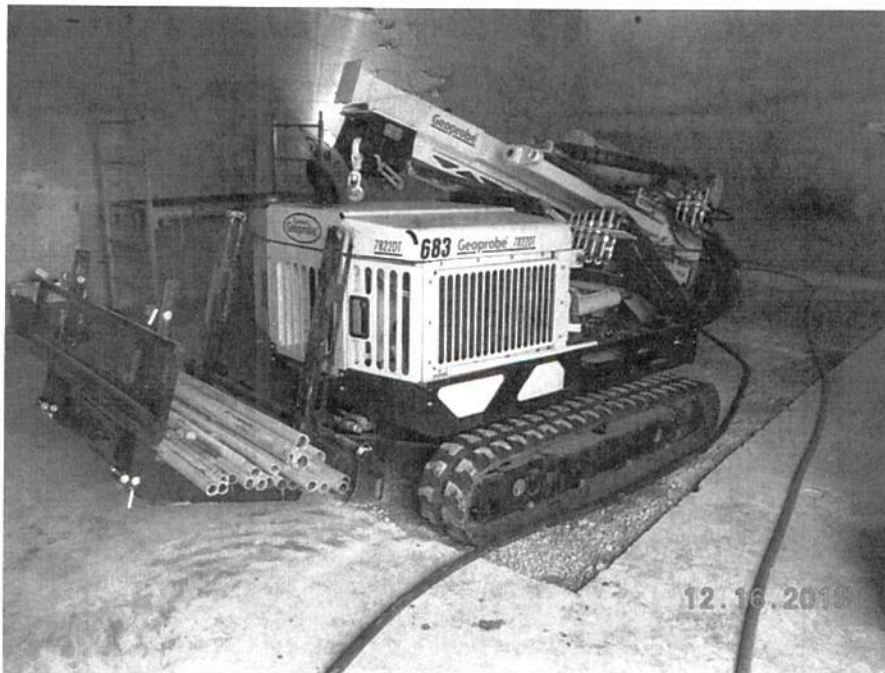
**PHOTO 26:**

Preparing to inject  
BOS 100 using  
Geoprobe 7822DT rig  
in Zone 7.
